Chicopee Center Walk Assessment Chicopee, MA

September 20, 2018

Walk Assessment Overview

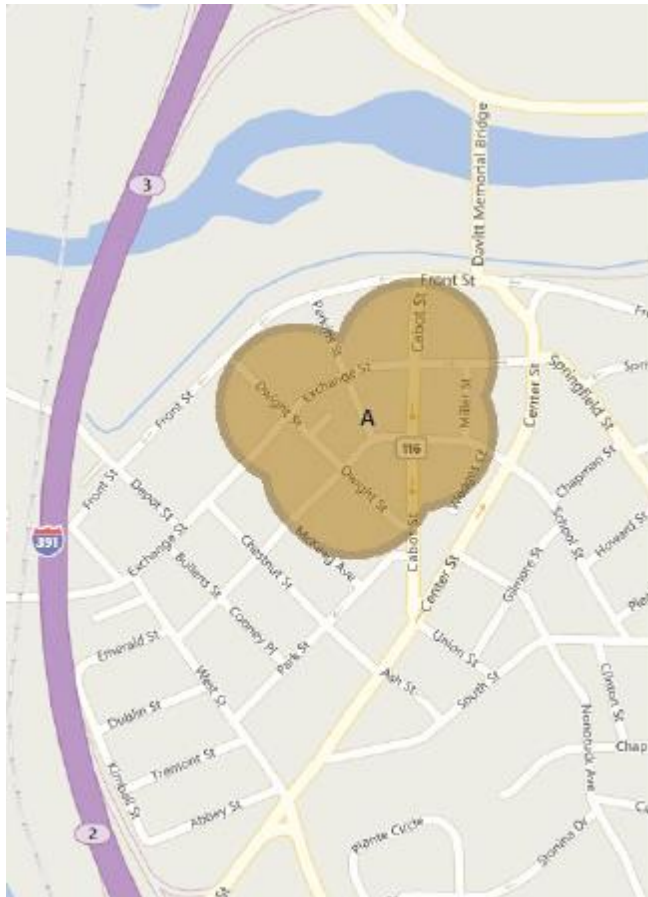
HSIP Pedestrian Clusters

A pedestrian crash cluster centered on Chicopee Center indicates potentially dangerous conditions for people walking.

WalkBoston consulted MassDOT’s Highway Safety Improvement Program (HSIP) crash portal to determine potential locations for the walk assessment. The data through 2015 show a pedestrian crash cluster in the heart of Chicopee Center that indicates potentially dangerous conditions for people walking. (The other pedestrian crash cluster in Chicopee is centered on Chicopee Street and Bolduc Lane in the Willimansett neighborhood, several miles north of the Center.) The City is working to encourage more business and pedestrian activity downtown, and the forthcoming redevelopment of two mill buildings on Front Street will mean hundreds of new residents living and walking in the Center. As such, improving pedestrian safety, accessibility and connectivity downtown is critical to advancing the City’s broader goals around housing and economic development.

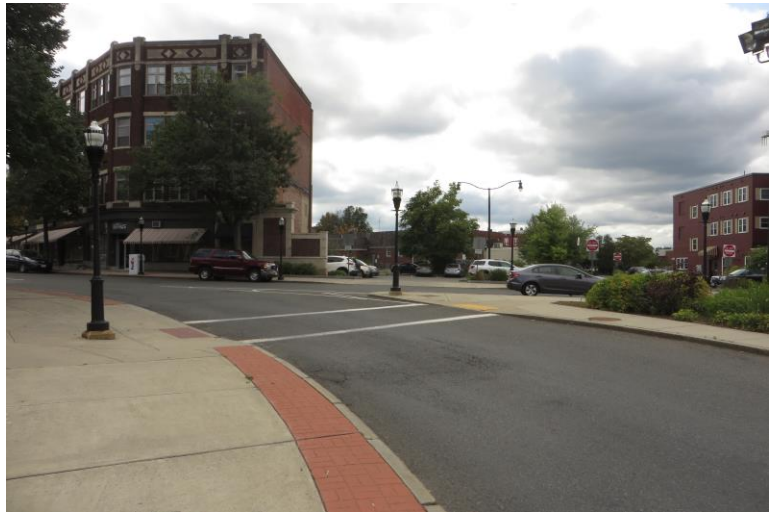
Front Street at Center Street

Just outside City Hall, people driving utilize a right-turning slip lane to merge from Center Street onto Front Street. Walk assessment participants noted that turning vehicles at this location often fail to slow down as they approach the crosswalks, creating a pedestrian safety hazard. **Strategies to improve walking safety include the following:**

Installing a raised crosswalk at the entrance to the right-turning slip lane outside City Hall will help calm traffic and improve pedestrian safety.

- **Paint a fog line along the slip lane to narrow the travel lane and calm traffic.**
- **Upgrade the crosswalk at the entrance to the slip lane to a raised crosswalk.** This will slow motor vehicles as they approach the slip lane, which will also improve pedestrian safety at the subsequent crosswalk across Front Street. Walk assessment participants noted that raised crosswalks are planned for several locations along Front Street east of City Hall, providing a replicable model for other parts of the City.
- **Upgrade crosswalks with a highly visible ladder design and signage, including in-street pedestrian delineators.**

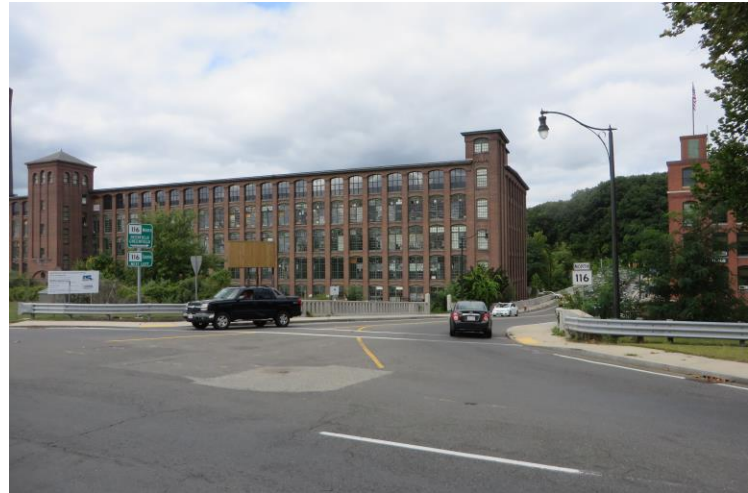
Front Street at Springfield Street

The intersection of Front Street and Springfield Street presents a number of pedestrian safety challenges. The elongated roadway geometry results in poor sightlines for pedestrians as well as drivers, and wide turning radii induce drivers to make turns at high speeds without slowing down. There are no pedestrian accommodations along Front Street on the northwest side of the intersection, and the sidewalks along Front Street on the northeast side of the intersection are relatively narrow.

Long crossing distances and wide turning radii for motor vehicles present safety challenges for pedestrians at the intersection of Front Street and Springfield Street.

intersection along Front Street and Springfield Street, respectively, but the WALK signals at these locations do not display pedestrian countdowns. There is no traffic or pedestrian signal on Springfield Street regulating the southbound approach to the intersection, which is one of the major vehicular access points into Chicopee Center. Drivers entering the Center this way have to take a roundabout loop on Front Street, Cabot Street, Exchange Street and Center Street, due to the current one-way westbound traffic pattern on Front Street.

- **Develop specific plans to address the lack of pedestrian accommodations along Front Street on the northwest side of the intersection.** Walk assessment participants discussed a future vision for a multiuse path in this area, as well as need to install new sidewalks as the mill redevelopments on Front Street move forward. Ensuring safe pedestrian facilities is critical to accommodate the future growth in residential and commercial activity projected for this area.

- **Install curb extensions/bumpouts and a pedestrian refuge island along the northern leg of the intersection at Springfield Street to calm traffic, reduce the long crossing distance, and improve pedestrian visibility.** Bumpouts and refuge islands can be added at low cost in the near term using paint, planters and/or plastic flex posts.

- **Upgrade crosswalks with a highly visible ladder design and signage, including in-street pedestrian delineators.**
- **Assess the current pedestrian signal cycle to ensure that pedestrians get frequent WALK signals with sufficient time to cross the street.**

- **Upgrade WALK signal equipment to display pedestrian countdowns in the longer term.**
- **Explore opportunities to widen the sidewalk along Front Street on the northeast side of the intersection.**
- **Consider implementing road diets on Front Street and Springfield Street.** Both Front Street and Springfield Street are two lanes wide at the eastbound and northbound approaches to the intersection, respectively. Front Street has one travel lane and one right-turning lane, and Springfield Street has one travel lane and one left-turning lane. This lane capacity is underutilized, which presents opportunities to reduce the number of travel lanes and reallocate excess roadway space to the pedestrian realm. This will also help calm traffic and further reduce pedestrian crossing distances.

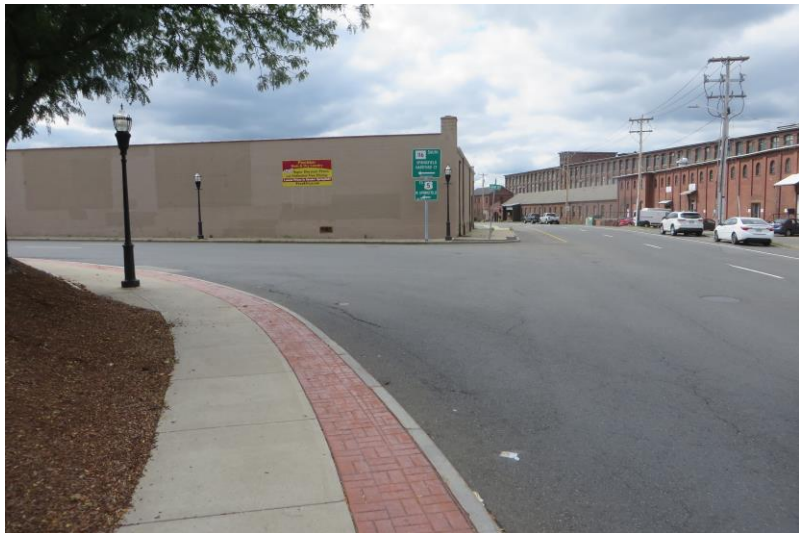
Front Street at Cabot Street

The turning radius for traffic turning left from Front Street onto Cabot Street is extremely wide, and as a result drivers can make this move at high speeds without slowing down. The lack of a crosswalk for pedestrians to get across four travel lanes on Cabot Street only compounds the pedestrian safety challenges at this location. Walk assessment participants noted that past construction plans for this intersection, which were never implemented due to lack of funding, included wider sidewalks on the west side of Cabot Street and the creation of a bus-only lane for PVTA buses. These measures should be incorporated into a future redesign of this intersection.

An extremely wide turning radius for motor vehicles and the lack of a marked crosswalk present safety challenges for pedestrians at the intersection of Front Street and Cabot Street.

- **Install a curb extension/bumpout on the southeast corner of the intersection to calm traffic turning left from Front Street onto Cabot Street.** As part of an installation at this corner, the excess roadway space can be repurposed into a pedestrian amenity like a small plaza or pocket park. A Bumpout can be added at low cost in the near term using paint, planters and/or plastic flex posts.
- **Install a crosswalk with ADA-compliant ramps and highly visible ladder design across Cabot Street.** This crosswalk should be installed in conjunction with the bumpout described above, which will also narrow the overall pedestrian crossing distance. In the longer term, crosswalks

should also be installed across Front Street as the mill redevelopments move forward and pedestrian accommodations are added on the north side of Front Street.

- **Implement a road diet on Cabot Street.** Cabot Street between Front Street and Exchange Street is four lanes wide (two travel lanes, plus a left-turning lane and a right-turning lane). This lane capacity is underutilized, which presents opportunities to reduce the number of travel lanes and reallocate excess roadway space to the pedestrian realm. This will also help calm traffic and further reduce pedestrian crossing distances.

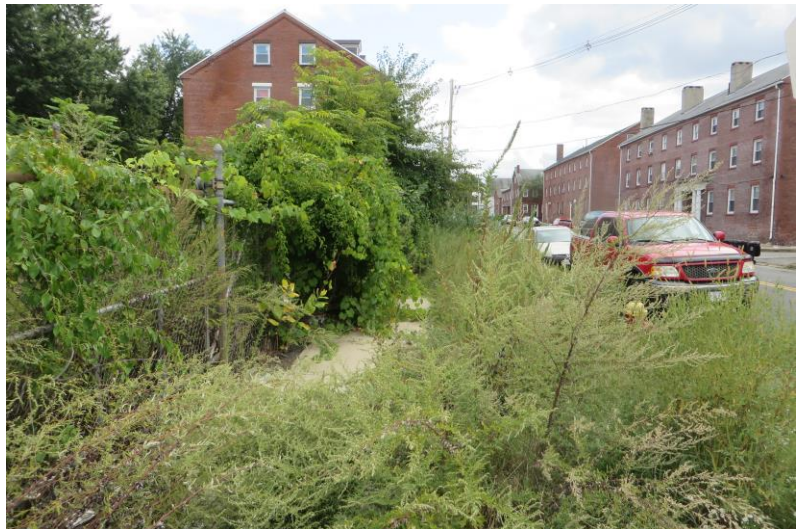
Front Street at Dwight Street

Dwight Street between Front Street and Exchange Street has several multifamily housing buildings with driveways in between them. The driveways interrupt the sidewalks and lack curb ramps. Walk assessment participants noted that in some instances the sidewalks are on private property, meaning that the City cannot install ramps directly. Some of the sidewalks are also completely blocked by shrubs and weeds. **Strategies to improve walking safety include the following:**

Overgrown sidewalks on Dwight Street should be cleared to ensure safe pedestrian access.

- **Explore property takings along the sidewalks or code enforcement via the Building or Health Departments as mechanisms to create ADA-compliant curb ramps at the driveways.**
- **Clear the overgrown sidewalk on the east side of Dwight Street to enable safe pedestrian access.**
- **Upgrade the crosswalk across Dwight Street to a more highly visible ladder design.**
- **Consider the future installation of crosswalks across Front Street as the mill redevelopment projects move forward.**

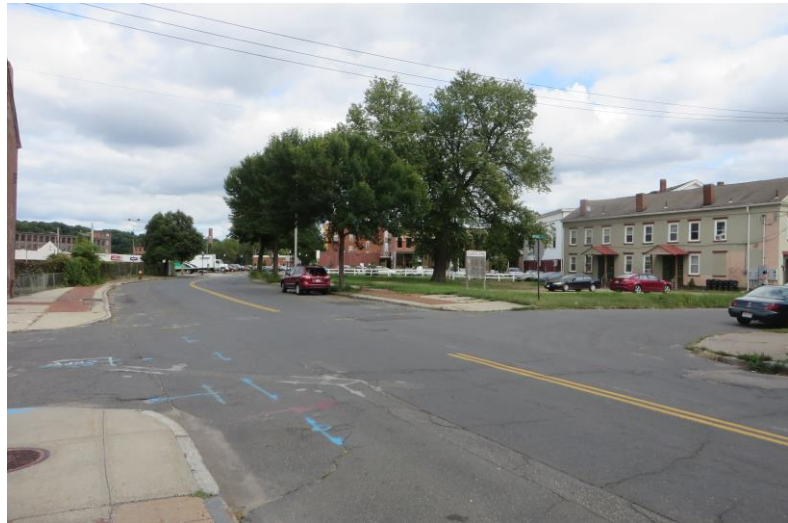
Exchange Street between Depot Street and Cabot Street

Exchange Street is relatively wide between Depot Street and Cabot Street, which can induce traffic to move at high speeds. There is also a lack of marked crosswalks along this stretch of Exchange Street, even though curb ramps are present. Many of these curb ramps lack the tactile warning panels required for ADA compliance. The sidewalks are largely comprised of brick, which some walk assessment participants suggested could be eliminated as part of future sidewalk reconstruction/expansion projects to create a smoother walking surface. **Additional strategies to improve walking safety include the following:**

Adding fog lines, crosswalk markings and signage, and ADA-compliant curb ramps and tactile warning panels will improve conditions for pedestrians on Exchange Street.

- **Add fog lines on Exchange Street to narrow the travel lanes and calm traffic.**
- **Add and upgrade crosswalks along and across Exchange Street (at Depot Street, Chestnut Street, Dwight Street and Perkins Street) with fresh paint and a highly visible ladder design and signage, including in-street pedestrian delineators on Exchange Street.**
- **Assess whether curb ramps are in a state of good repair and add tactile warning panels for ADA compliance where needed.**
- **Expand the sidewalk on the north side of Exchange Street between Perkins Street and Cabot Street.** Streetlights and parked cars at the Market Square Plaza shopping center create a crowded and unpleasant walking environment for pedestrians at this location. Creating an expanded sidewalk here will improve walkability and also help calm traffic by narrowing the vehicular travel lane on the north side of the street.

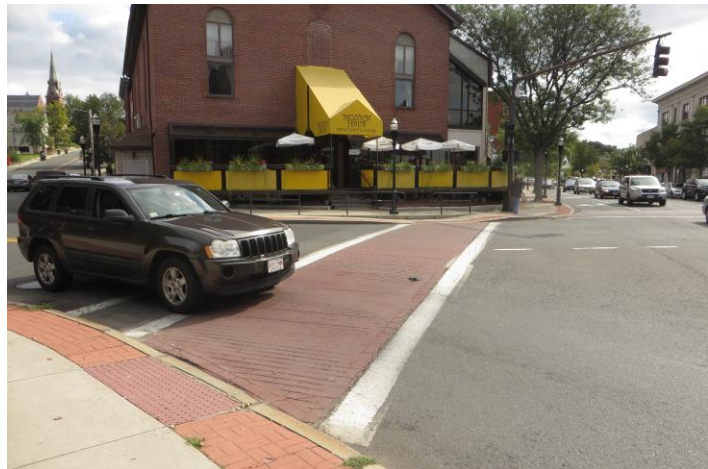
Exchange Street at Center Street/Springfield Street

The intersection of Exchange Street, Center Street and Springfield Street presents several pedestrian safety challenges. The traffic pattern is confusing, sightlines are poor for pedestrians as well as drivers, and wide turning radii induce drivers to make turns at high speeds without slowing down. In addition, the WALK signal cycle does not provide pedestrians with enough time to cross the street. **Strategies to improve walking safety include the following:**

Wide turning radii for motor vehicles present safety challenges for pedestrians at the intersection of Exchange Street, Center Street and Springfield Street.

- **Install curb extensions/bumpouts on the eastern leg of the intersection at Springfield Street to calm traffic, reduce crossing distances, and improve pedestrian visibility.** Bumpouts can be added at low cost in the near term using paint, planters and/or plastic flex posts.
- **Update the pedestrian signal cycle to provide more WALK time to cross the street.**
- **Implement road diets on Exchange Street and Center Street.** Both Exchange Street and Center Street are three lanes wide at the intersection. Exchange Street has one travel lane and two left-turning lanes, and Center Street has two travel lanes and one right-turning lane. This lane capacity is underutilized, which presents opportunities to reduce the number of travel lanes and reallocate excess roadway space to the pedestrian realm. This will also help calm traffic and further reduce pedestrian crossing distances.
